# TUNNEL CONDITION ASSESSMENT REPORT

## SENIOR CANYON TUNNEL OJAI, CALIFORNIA

May 15, 2017

**J | C | K**  
**UNDERGROUND**

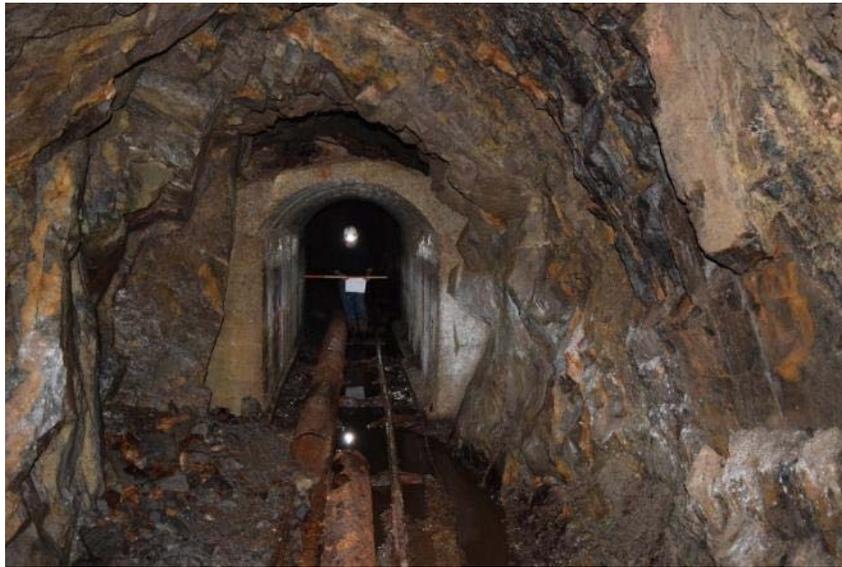
The concrete lined sections of the tunnel appear to be in good shape, however there is a large void above the liner at Station 5+46 to 5+62 (See Figure 5-3). Within this void is a large wedge of rock directly above the liner that could cause damage if it falls.

*Figure 5-3: Horseshoe-shaped CIP Concrete Liner with Open Annulus at Crown at Station 5+46*

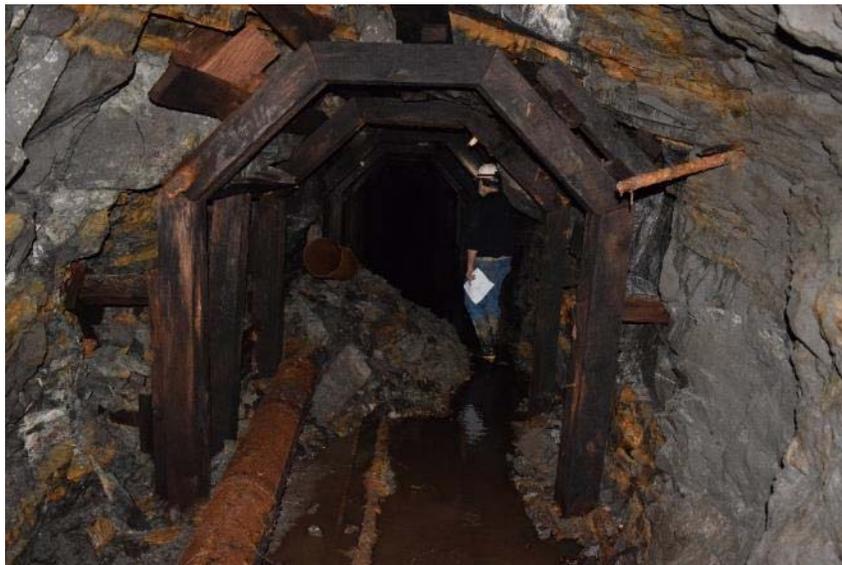
The timber sets from Station 12+68 to 13+02 were most likely installed during the original tunnel construction and have been exposed to water conditions throughout its lifetime. The rock within this zone has a shallow dipping plane which resembles slabbing at the crown, hence the use of the timber sets as an initial support. The timber sets are 6 by 8 inches in area and are set up in a trapezoidal shape with occasional blocking to provide contact with the rock. From observation, the timbers are soft and spongy and unreliable as a support. A large pile of rock, most likely fallout from the sidewall, was noted at the left side of the invert (looking upstream). Figure 5-4 (below) shows a photograph of the trapezoidal-shaped timber sets.

*Figure 5-4: Trapezoidal-shaped Timber Sets and Rock Debris at Invert at Station 12+68*

Rock blocks may fall from the tunnel walls as they loosen with time. Figure 5-4 above shows rock fallout at Station 12+70 supported by the timber sets. Rock block fallout was also observed at Stations 11+50, 11+95, 12+70, 15+40, 15+50, and 15+55. The rock fallout data collected is tabulated in Table 8 in Appendix A.

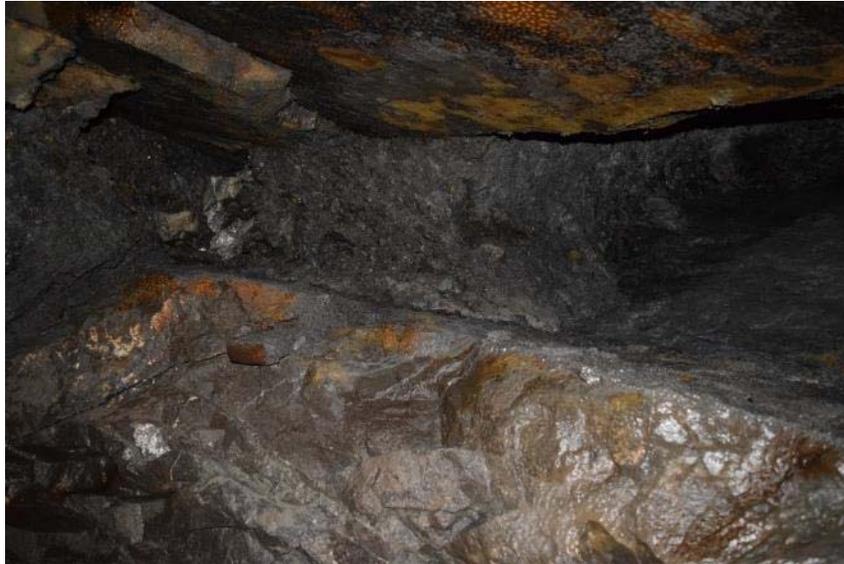
Faults are thin features that are fully packed with very dense pulverized material (see Figure 5-6). The infill material may loosen with time when exposed to air and fall to the invert. Given enough time, the fallout can create an obstruction, as it has at Station 24+00 (see Figure 5-7). The potential for similar fallout may exist at Stations 13+59, 14+97, 15+48, and 20+30, where faults crossing the tunnel have been identified.

*Figure 5-6: Pulverized Material within a fault at Station 20+30*

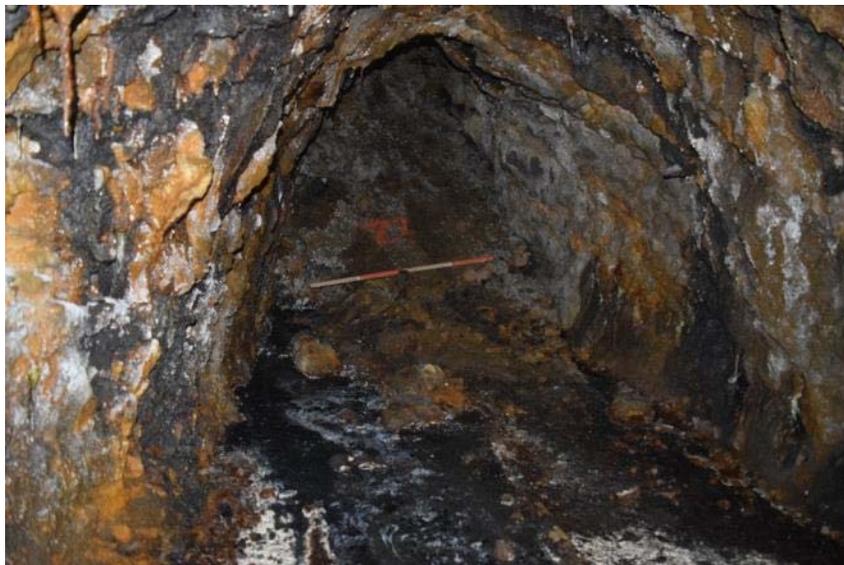
Based on SCMWC officials, at one time the stacked material at Station 24+00 did not fully seal the tunnel and could be “looked-over”. It is reported that one could observe the tunnel extending well beyond the stack of fallen material. During the December 2016 geometric survey, approximately 1 gpm or less of flowing water was observed coming from the toe of the piled material.

*Figure 5-7: Obstructed Tunnel from Fallen Material at Station 24+00*

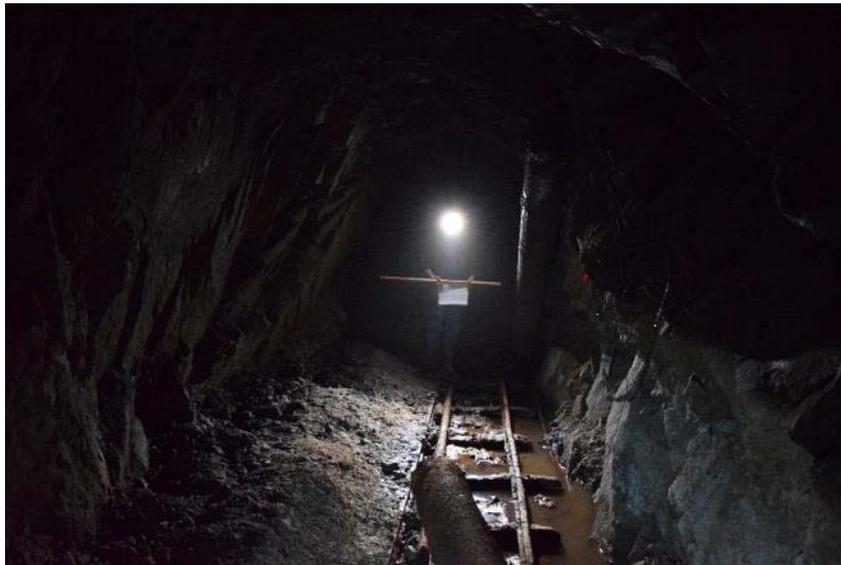
The rail runs the length of the tunnel and consist of 16 pound tees, wooden ties and track ballast. The rail tees are corroded and the wood ties are deteriorated. For most of the tunnel, the tees are spaced with a narrow track gauge of approximately 2 feet. However, where the ties are broken or missing the track ballast has pushed the tees closer together. Figure 5-8 shows the rail system at approximate Station 6+50, where it appears that the track ballast on the right side of the rail has been moved to the left side in an attempt to improve water flow along the invert.

*Figure 5-8: Typical Tunnel Invert with Debris, Rail System, and Flow (Photograph taken at Station 6+50)*

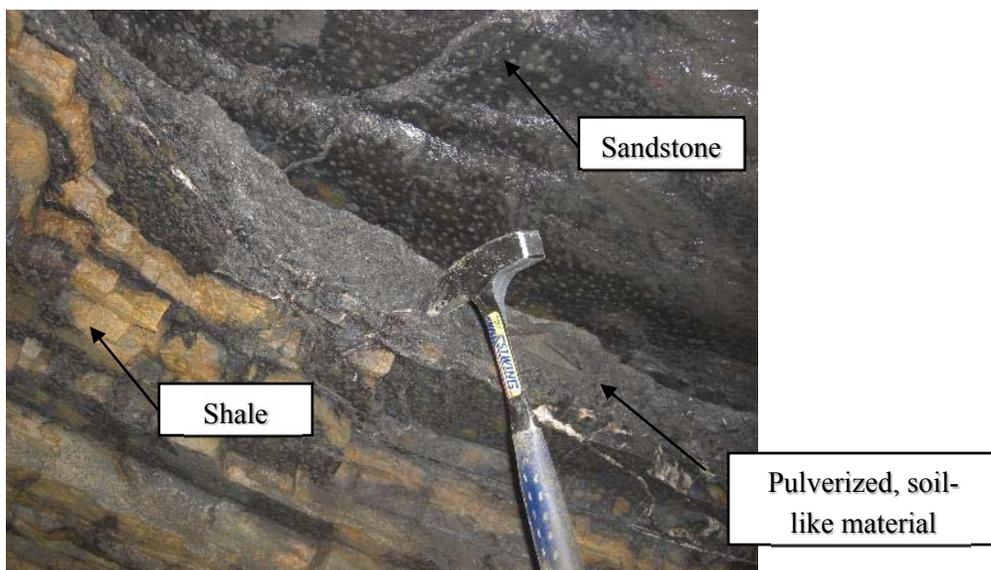
Figure 6-2: Geologic Hammer Inserted within Layer of Pulverized Material at Sandstone/Shale Contact

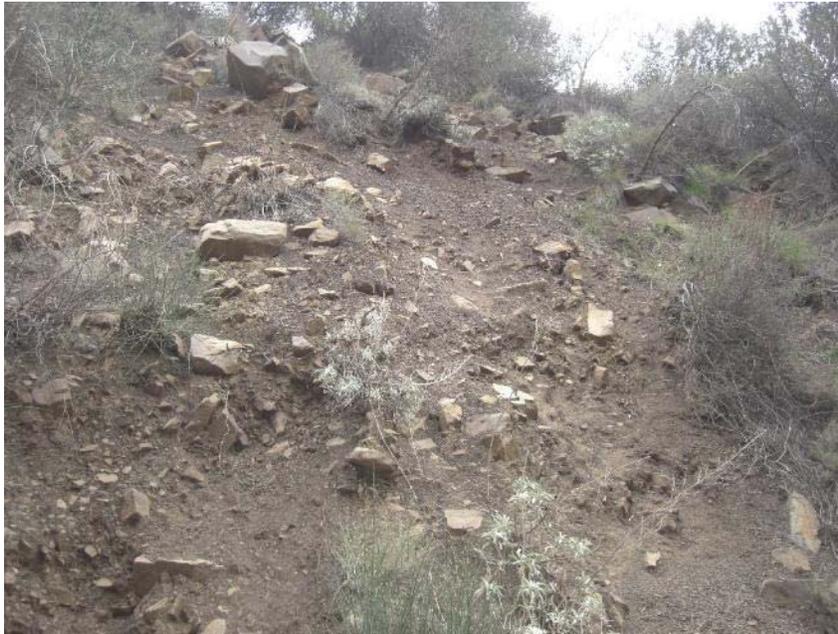
The slope south of the staging area contains loose rocks and boulders which may be a safety hazard. During the February 2017 inspection, multiple small rocks were observed rolling down the slope and onto the staging area, as shown in Figure 10-3. It is recommended to include improvements of the south slope as part of the contractor mobilization requirements. Improvements may include removal of large blocks from the slope, and constructing a temporary barrier to prevent smaller rocks and boulders from entering the staging area.

*Figure 10-3: Portal Staging Area South Slope with Loose Rocks and Boulders*

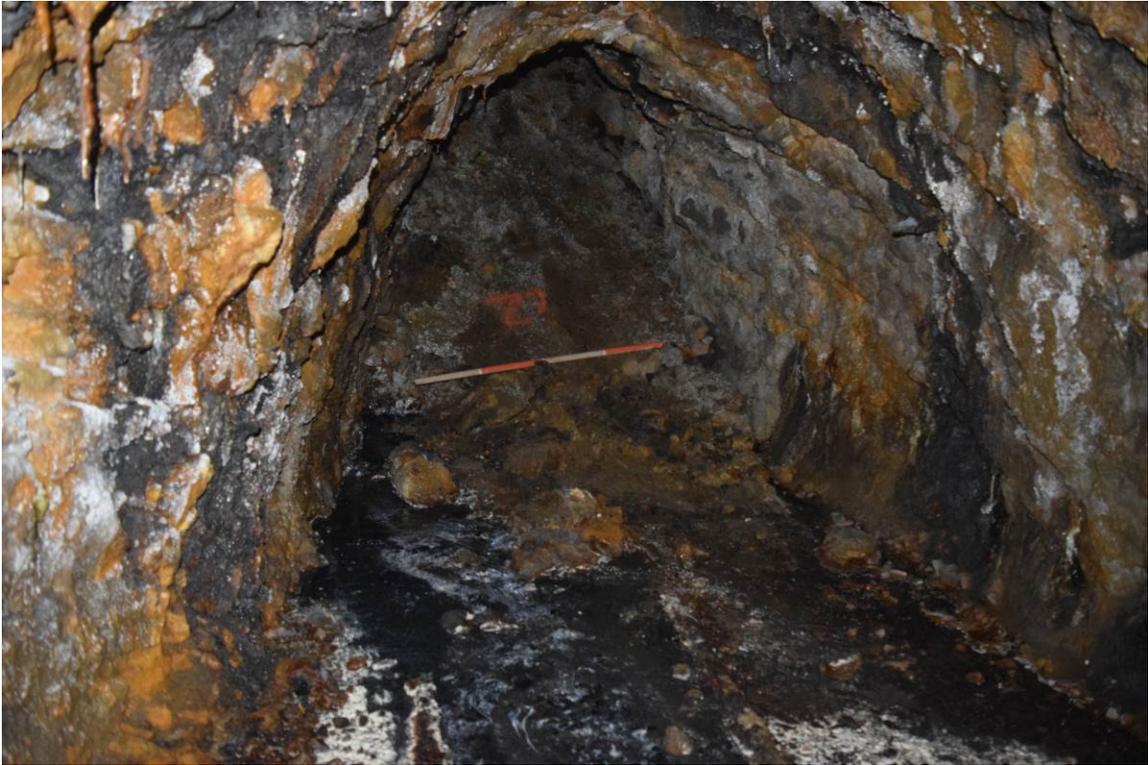
*Photograph 33. Sta. 24+00 at obstructed location (looking upstream)*

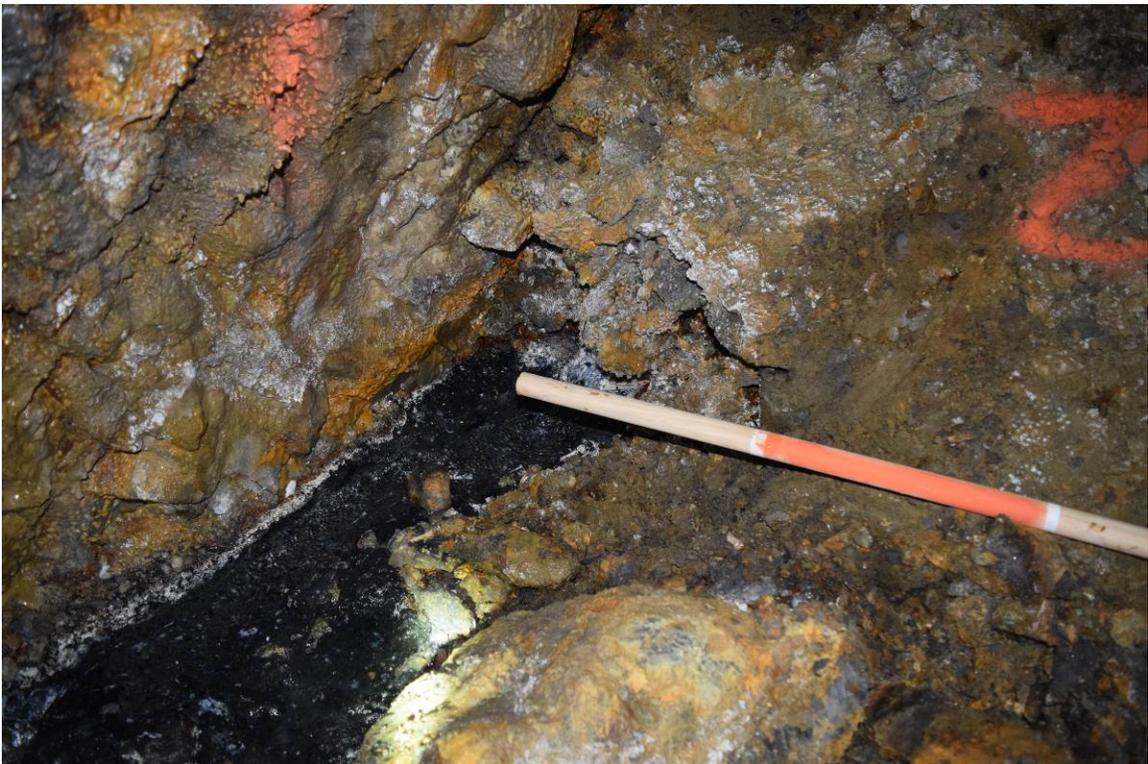
*Photograph 34. Sta. 24+00, water at invert at obstructed location (looking upstream)*

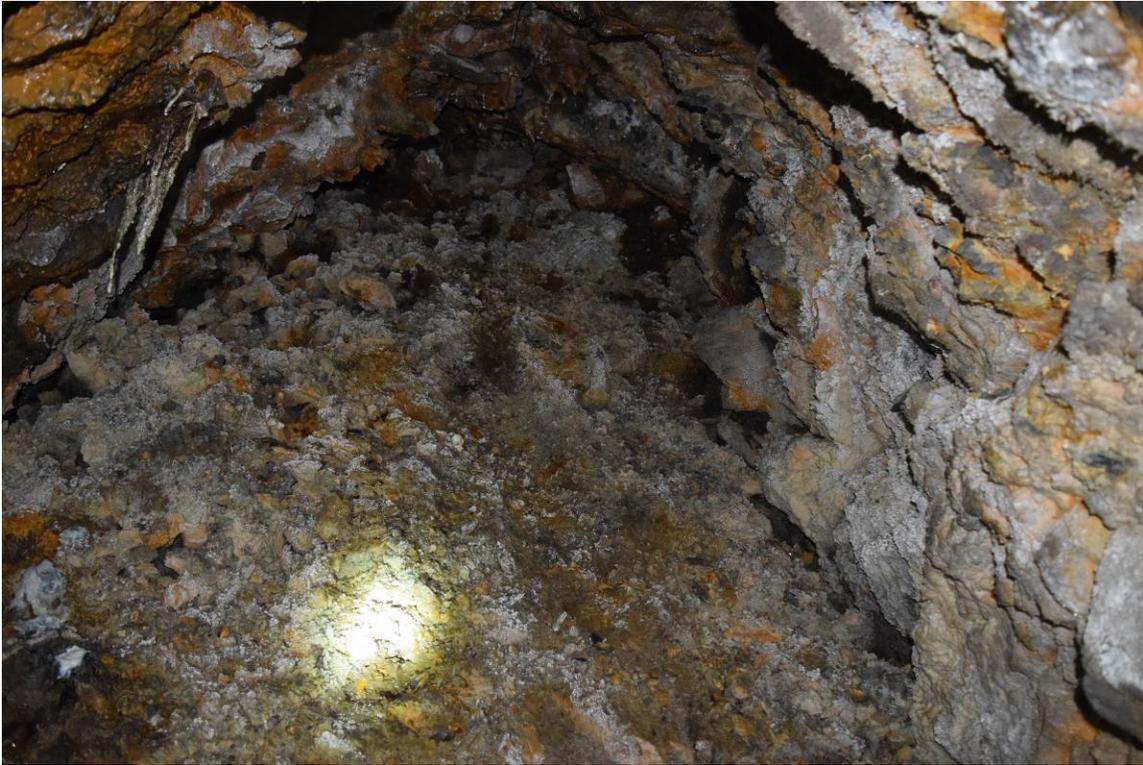
*Photograph 35. Sta. 24+00 at obstructed location (looking upstream)*
