# TUNNEL CONDITION ASSESSMENT REPORT

## SENIOR CANYON TUNNEL OJAI, CALIFORNIA

May 15, 2017

**J | C | K**  
**UNDERGROUND**

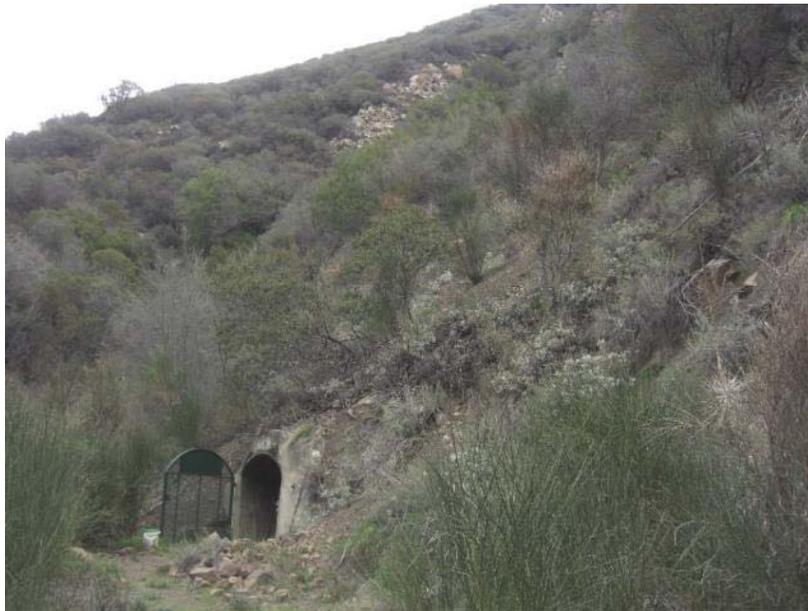
*Figure 3-1: Senior Canyon Tunnel Portal Staging Area and Hillside above the Tunnel Alignment*

Geotechnical borings above the tunnel are not available so the actual depth of bedrock is unknown, but it is assumed to be shallow based on observations of numerous rock outcrops. Below shows a photograph of a portion of the access area at the portal and the hillside above the tunnel alignment.

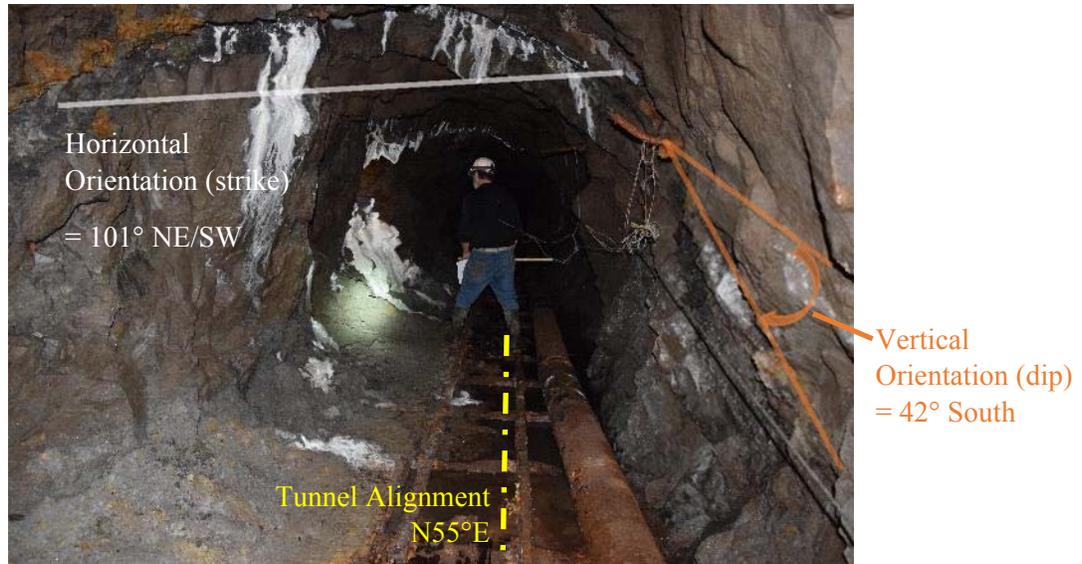
Figure 6-1: Horizontal and Vertical Orientation (Strike and Dip) of Bedding at Station 8+50

Figure 6-1 below shows the horizontal and vertical orientation of a bedding at Station 8+50.

- Inflows coming up through the invert are difficult to see due to the track ballast. However, there is evidence that inflows are occurring. Pinholes, created by water seepage, were observed in areas where the track ballast was submerged.
- Staining and calcite deposits (see Figure 6-1 and Photographs 11 and 12 in Appendix B at Station 8+50) were observed on the sidewalls in areas producing inflows; but, there were multiple locations where calcite deposits were observed but no inflows were present (e.g. Stations 8+50(±), 9+36, 9+85, 11+47 to 11+50). Calcite deposits may have sealed the joints that were once producing water.

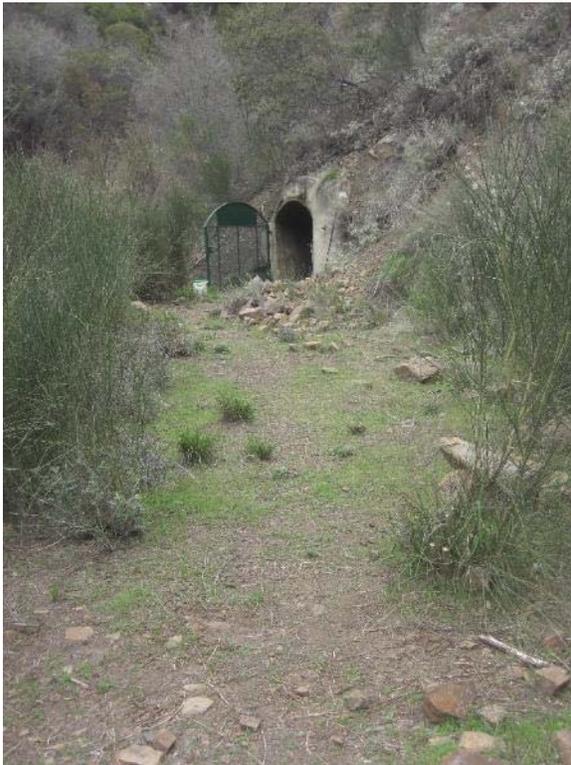
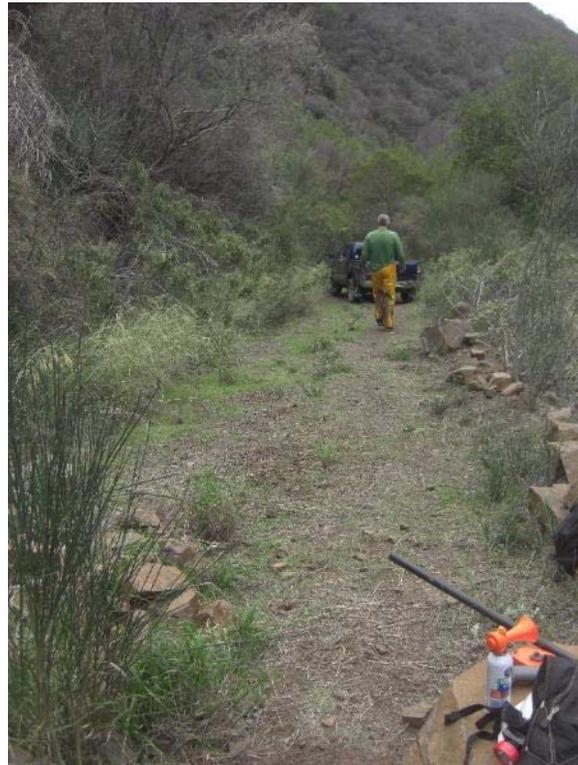
***Figure 10-2: Staging Area Looking North and South***

Figure 10-2 shows the staging area, looking north and south.

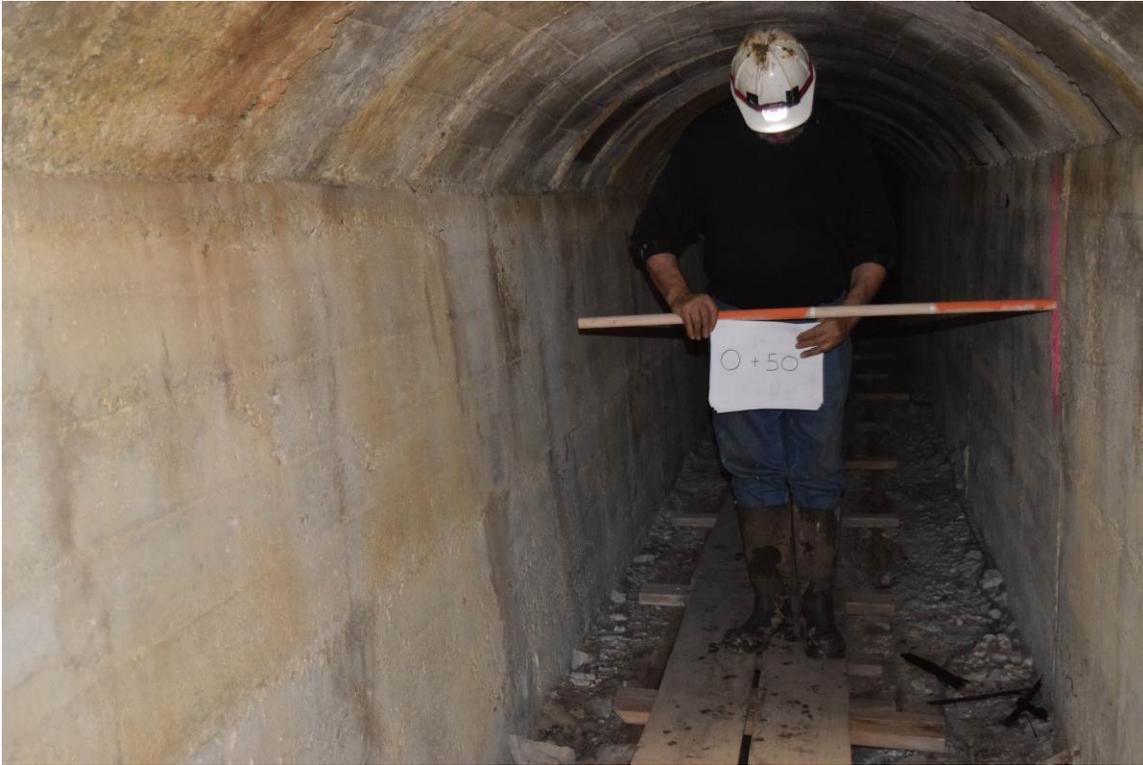
*Photograph 3. Sta. 0+50 at concrete liner (looking upstream)*

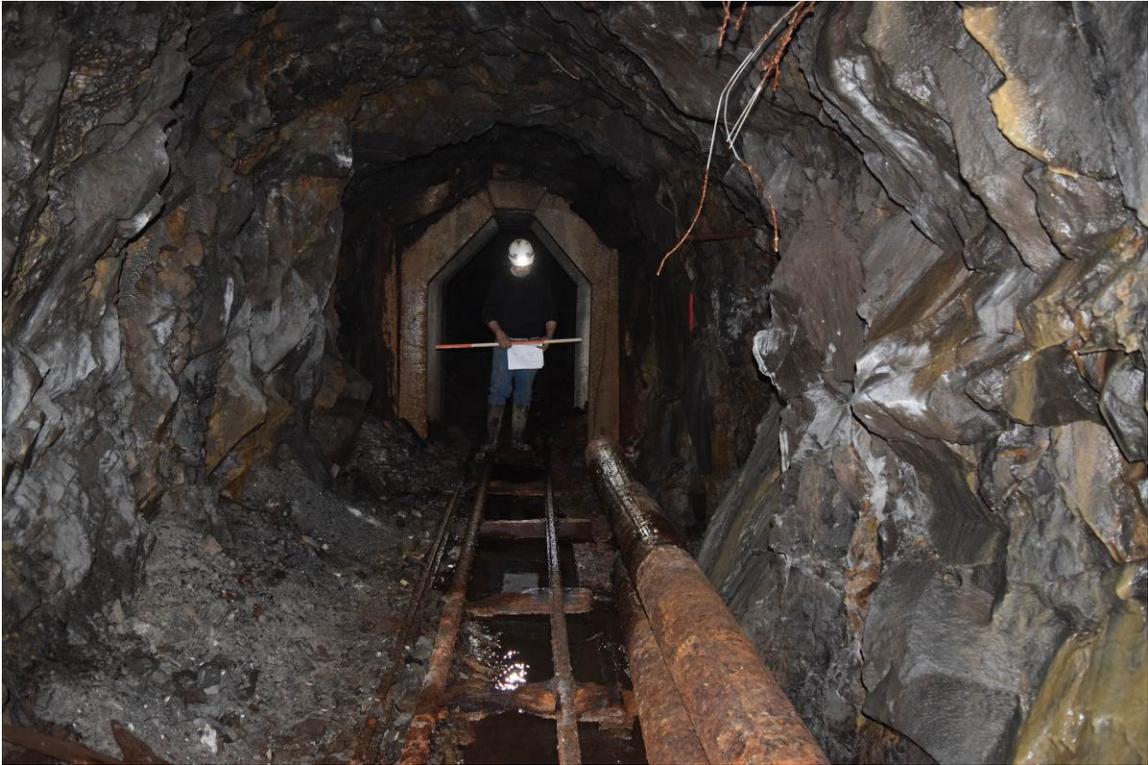
*Photograph 7. Sta. 4+50 at concrete trapezoidal sets (looking upstream)*

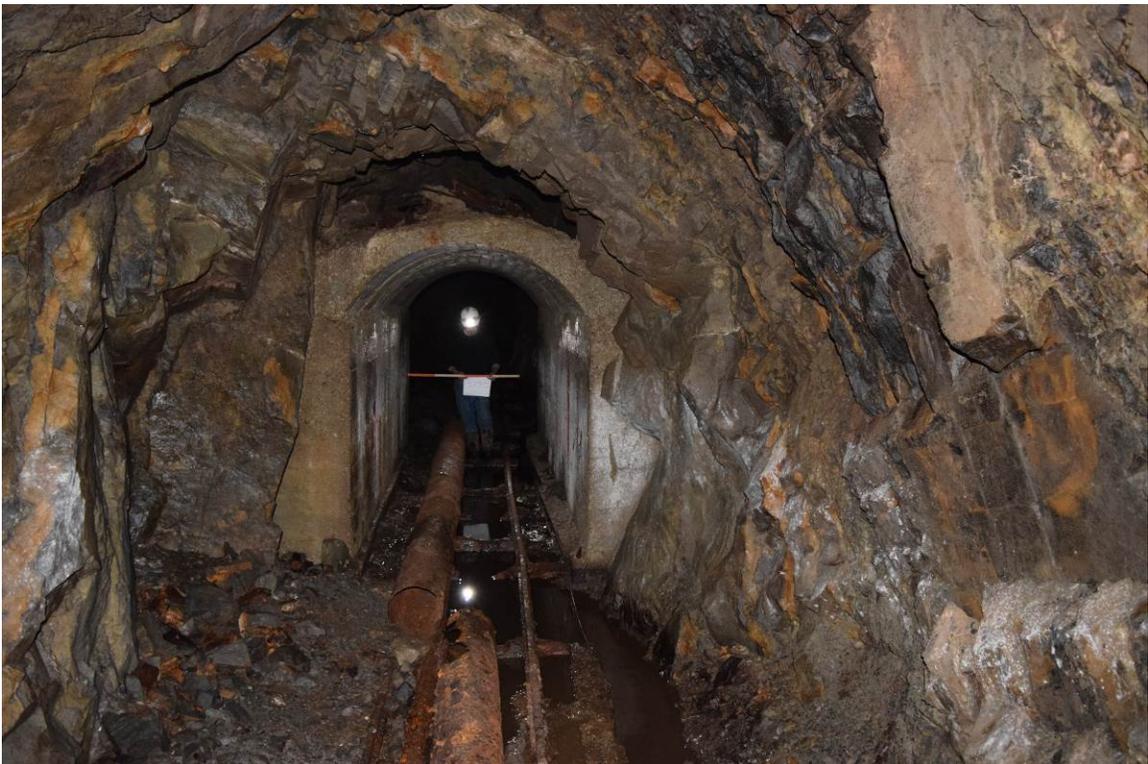
The concrete lined sections of the tunnel appear to be in good shape, however there is a large void above the liner at Station 5+46 to 5+62 (See Figure 5-3). Within this void is a large wedge of rock directly above the liner that could cause damage if it falls.

*Photograph 8. Sta. 5+50 at concrete liner (looking upstream)*

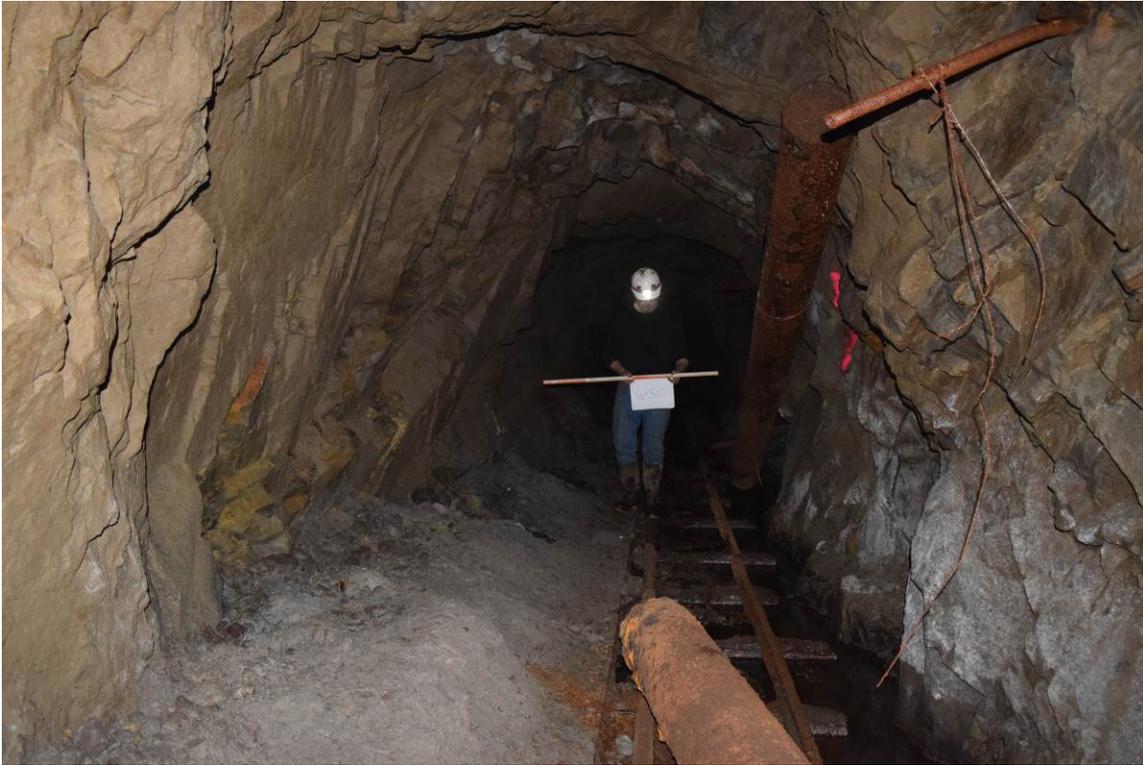
*Photograph 9. Sta. 6+50 (looking upstream)*

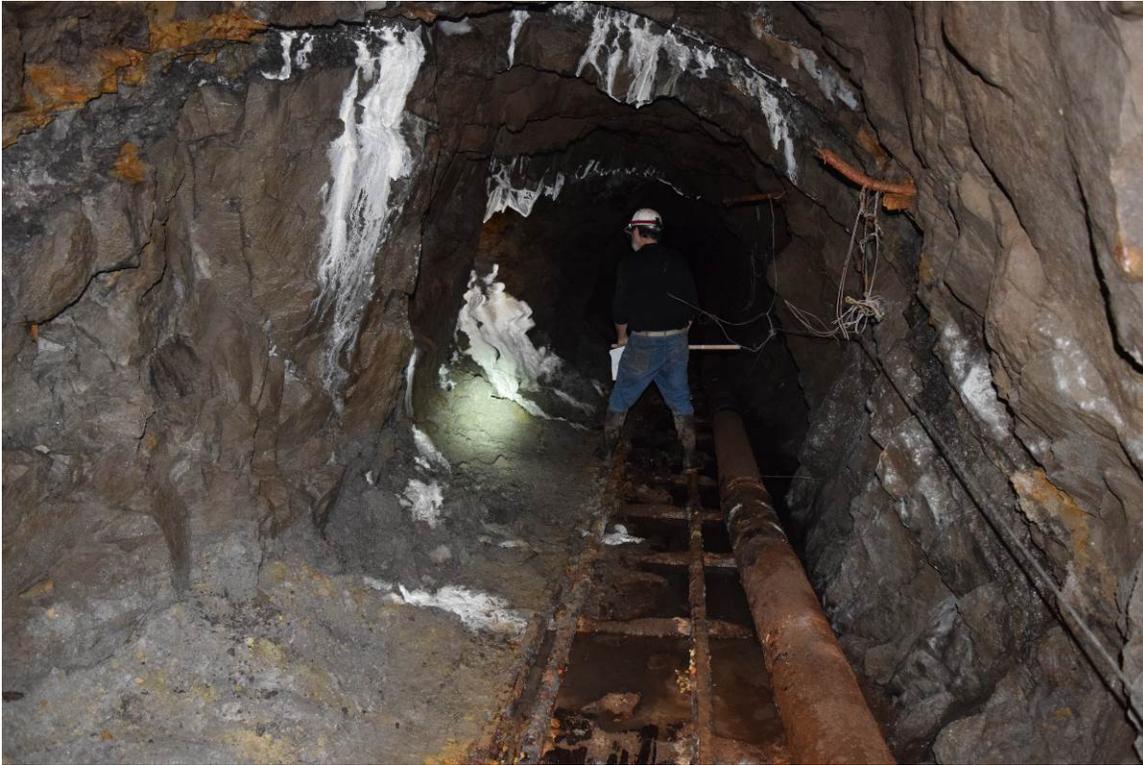
*Photograph 11. Sta. 8+50 (looking upstream)*

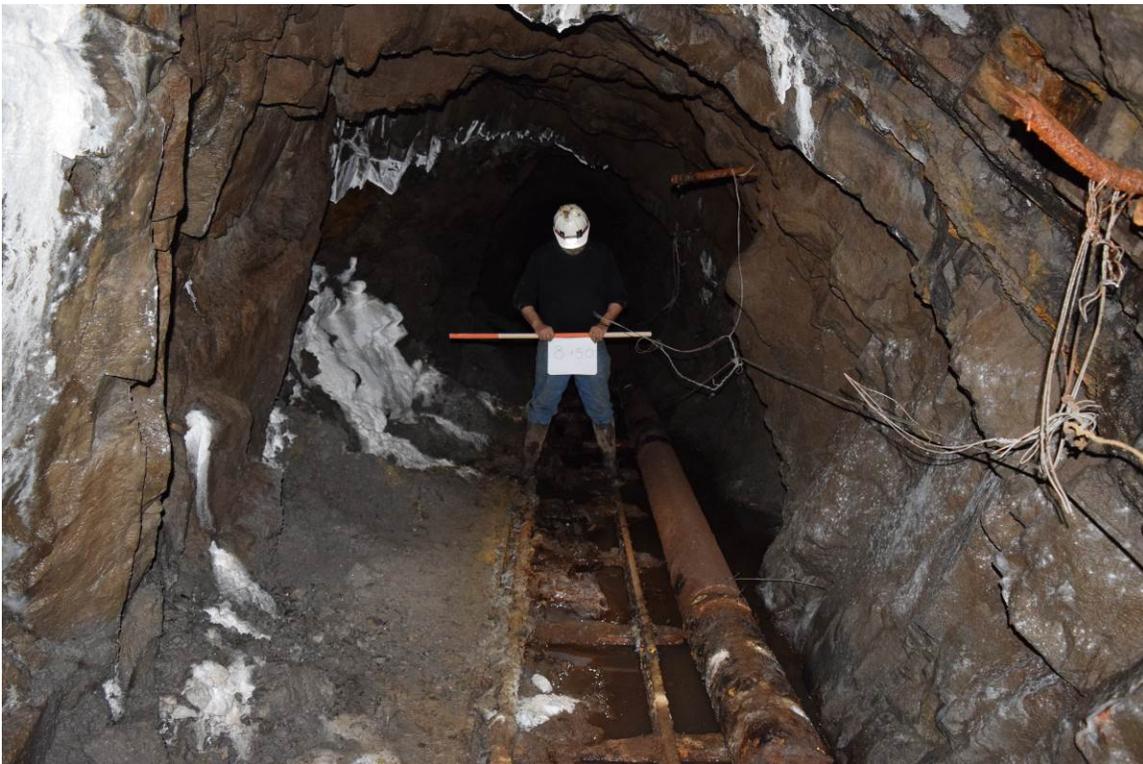
*Photograph 12. Sta. 8+50 (looking upstream)*

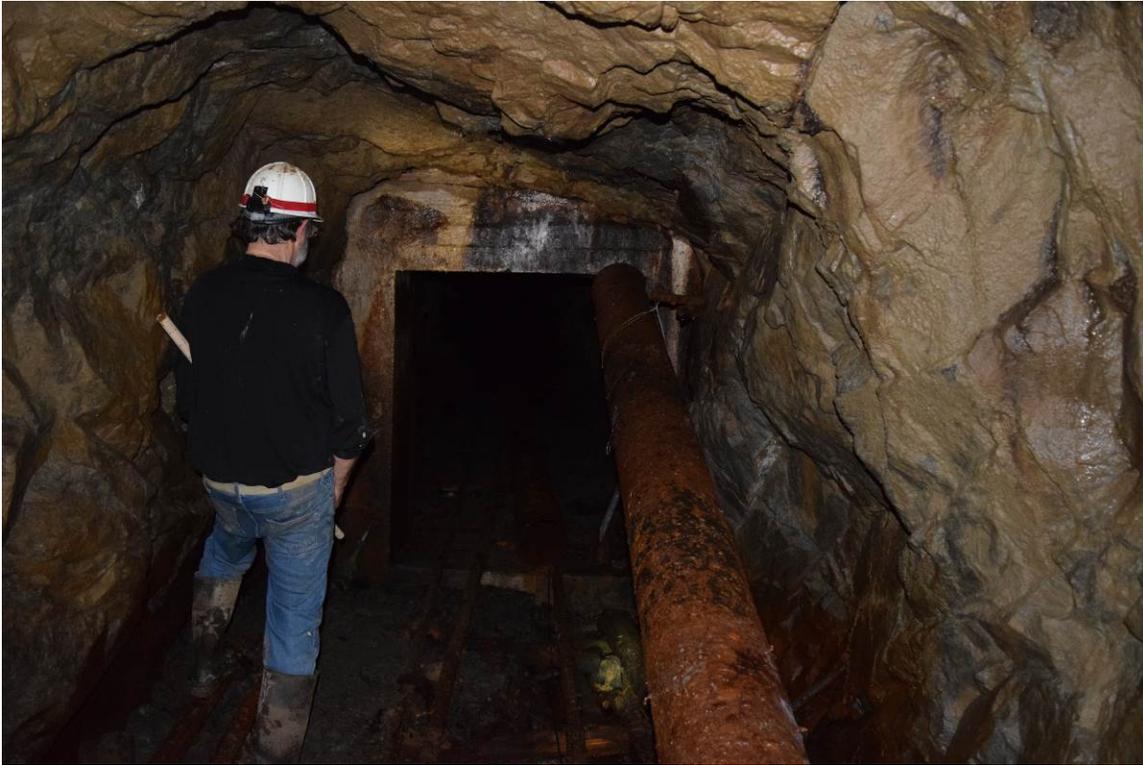
*Photograph 15. Sta. 10+84 at bulkhead door and concrete frame (looking upstream)*

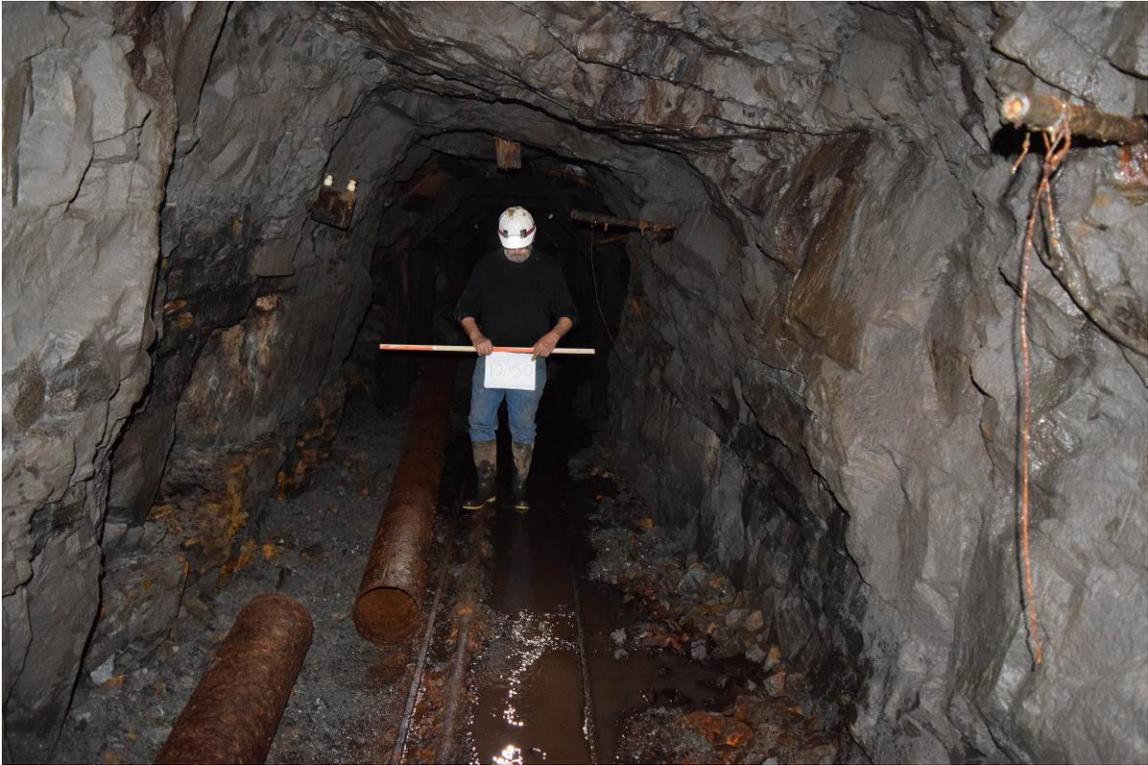
*Photograph 18. Sta. 12+68 at wood sets (looking upstream)*

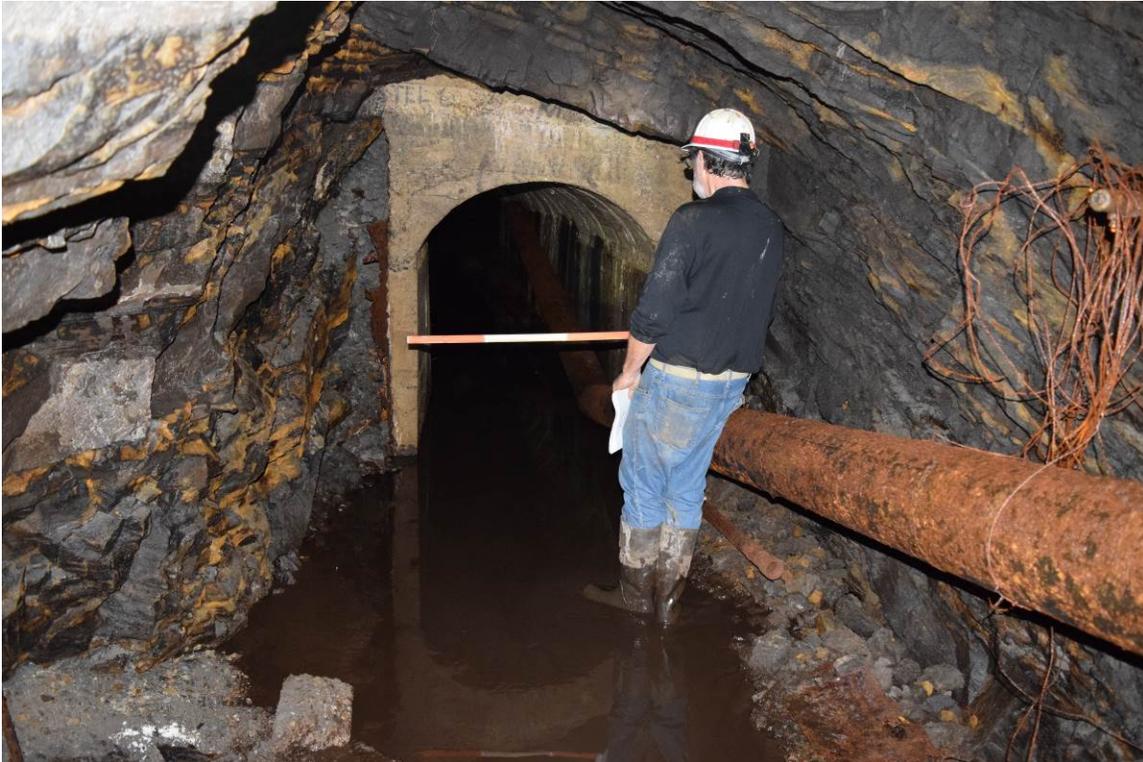
*Photograph 21. Sta. 14+61 at concrete liner (looking upstream)*

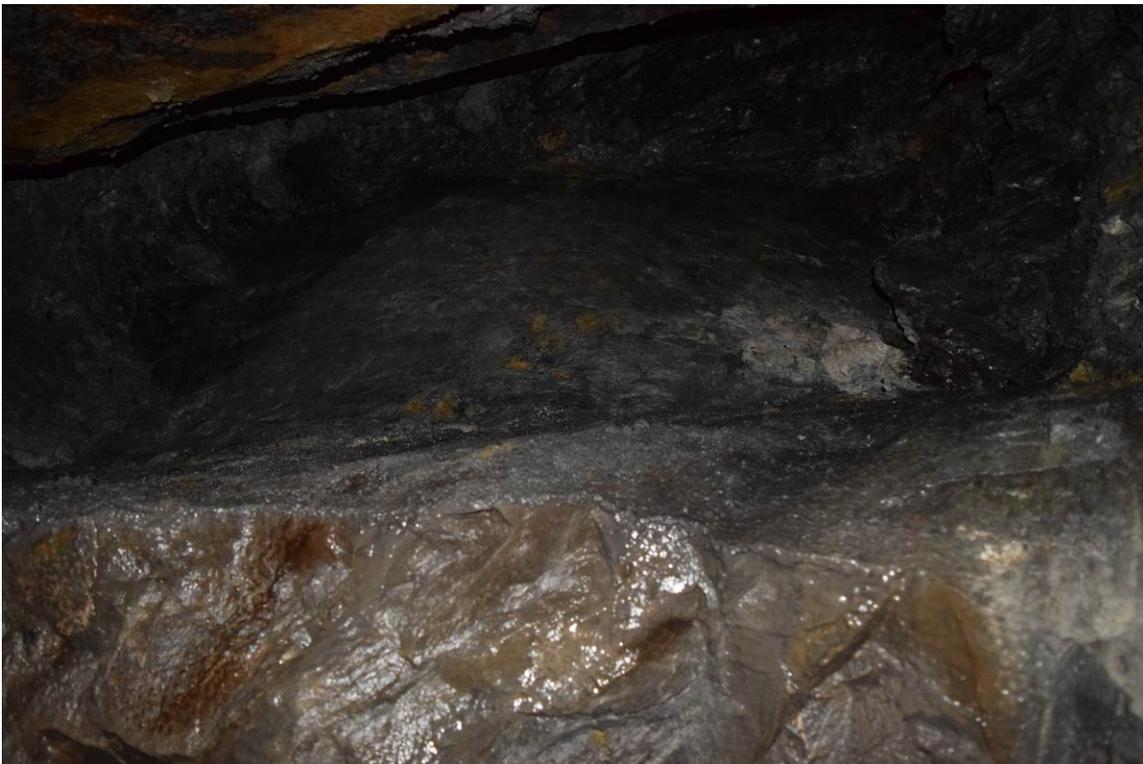
*Photograph 27. Sta. 20+30 at fault (looking upstream)*

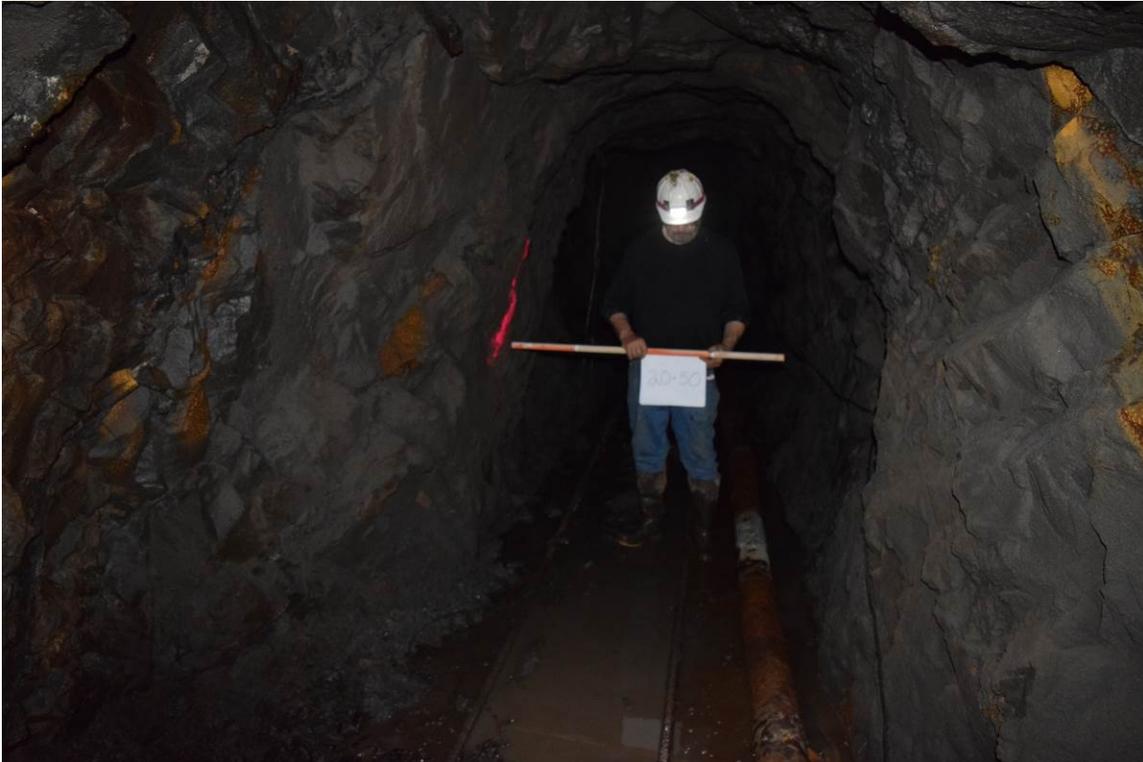
Fault zones are present in the rock mass, as evidence by the presence of pulverized material filled within vertical fractures that run perpendicular to the tunnel at five (5) identified locations: Stations 13+59, 14+97, 15+48, 20+30 (see Photograph 28 in Appendix B), and 24+00 (see Figures 5-6 and 5-7). The two faults located beyond Station 16+00 (at Stations 20+30 and 24+00), were located during the geometric survey in December 2016. The faults range in thickness from 4 to 22 inches, and are filled with pulverized material (e.g. intact gravel sized rock fragments and soil-like material). As previously discussed, the pulverized material slowly unravels, falls out and piles up on the invert, as shown in Figure 5-7. The fallout does not seem to be de-stabilizing the rock mass, but it is limiting access beyond Station 24+00.

*Photograph 28. Sta. 20+30 at fault (looking at crown)*
